**NORMAN Y. MINETA-SAN JOSE INTERNATIONAL AIRPORT
RUNWAY INCURSION MITIGATION / AIRFIELD DESIGN STANDARDS
ANALYSIS**

**TECHNICAL MEMORANDUM:
ANALYSIS OF RUNWAY INCURSION AND
SURFACE INCIDENTS
2000 – TO PRESENT**

KIMLEY HORN TEAM

February 15, 2017

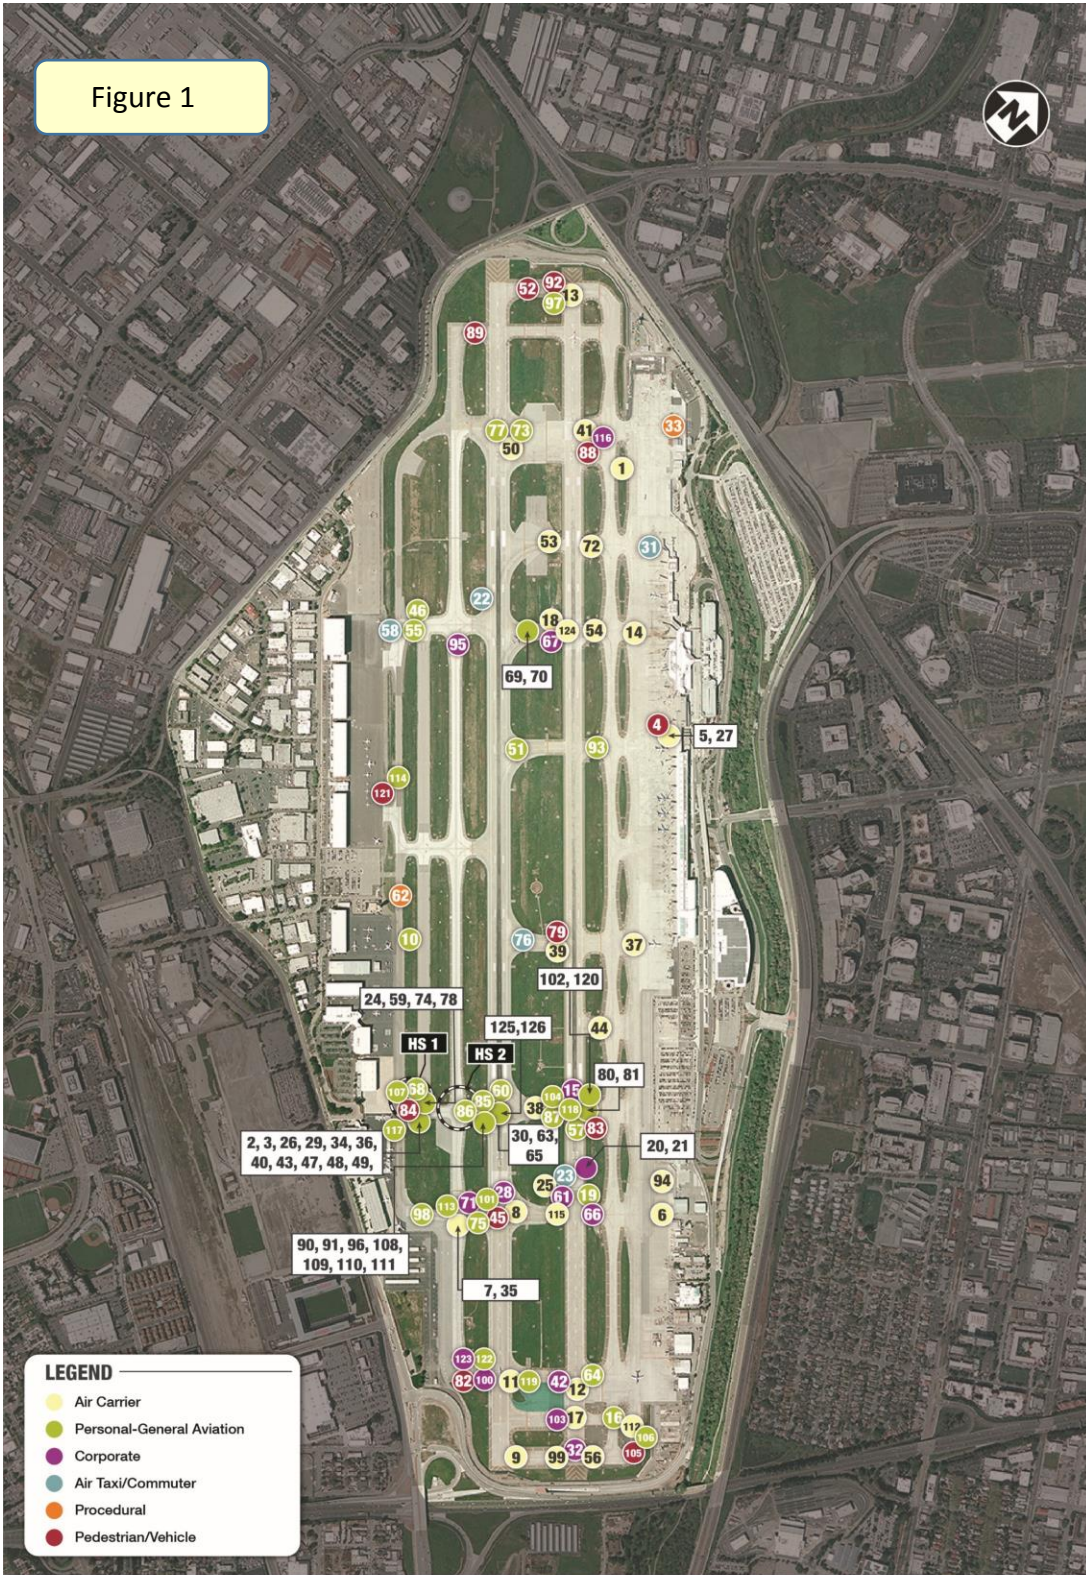
Figure 1

Following **Table 1** are three maps displaying the location of each incident identified in the table. **Figure 1** shows the location of all 126 incidents from 2000 to Present. **Figure 2** shows the location of incidents occurring from 2000 through late 2009 when Runway 11/29 was operational. **Figure 3** shows the location of incidents occurring from 2010 to the present, corresponding with the period when Runway 11/29 has been closed and more recently re-designated as interim Taxiway W-1, which is its current status.
